Mapped, edited, and published by the Geological Survey  
Kentucky area mapped in cooperation with State of Kentucky  
Geological Survey

MAYSVILLE EAST, OHIO-KY.  
NW/4 SPRINGDALE 15' QUADRANGLE  
N3837.5-W8337.5/7.5  
PHOTOINSPECTED 1983  
1961

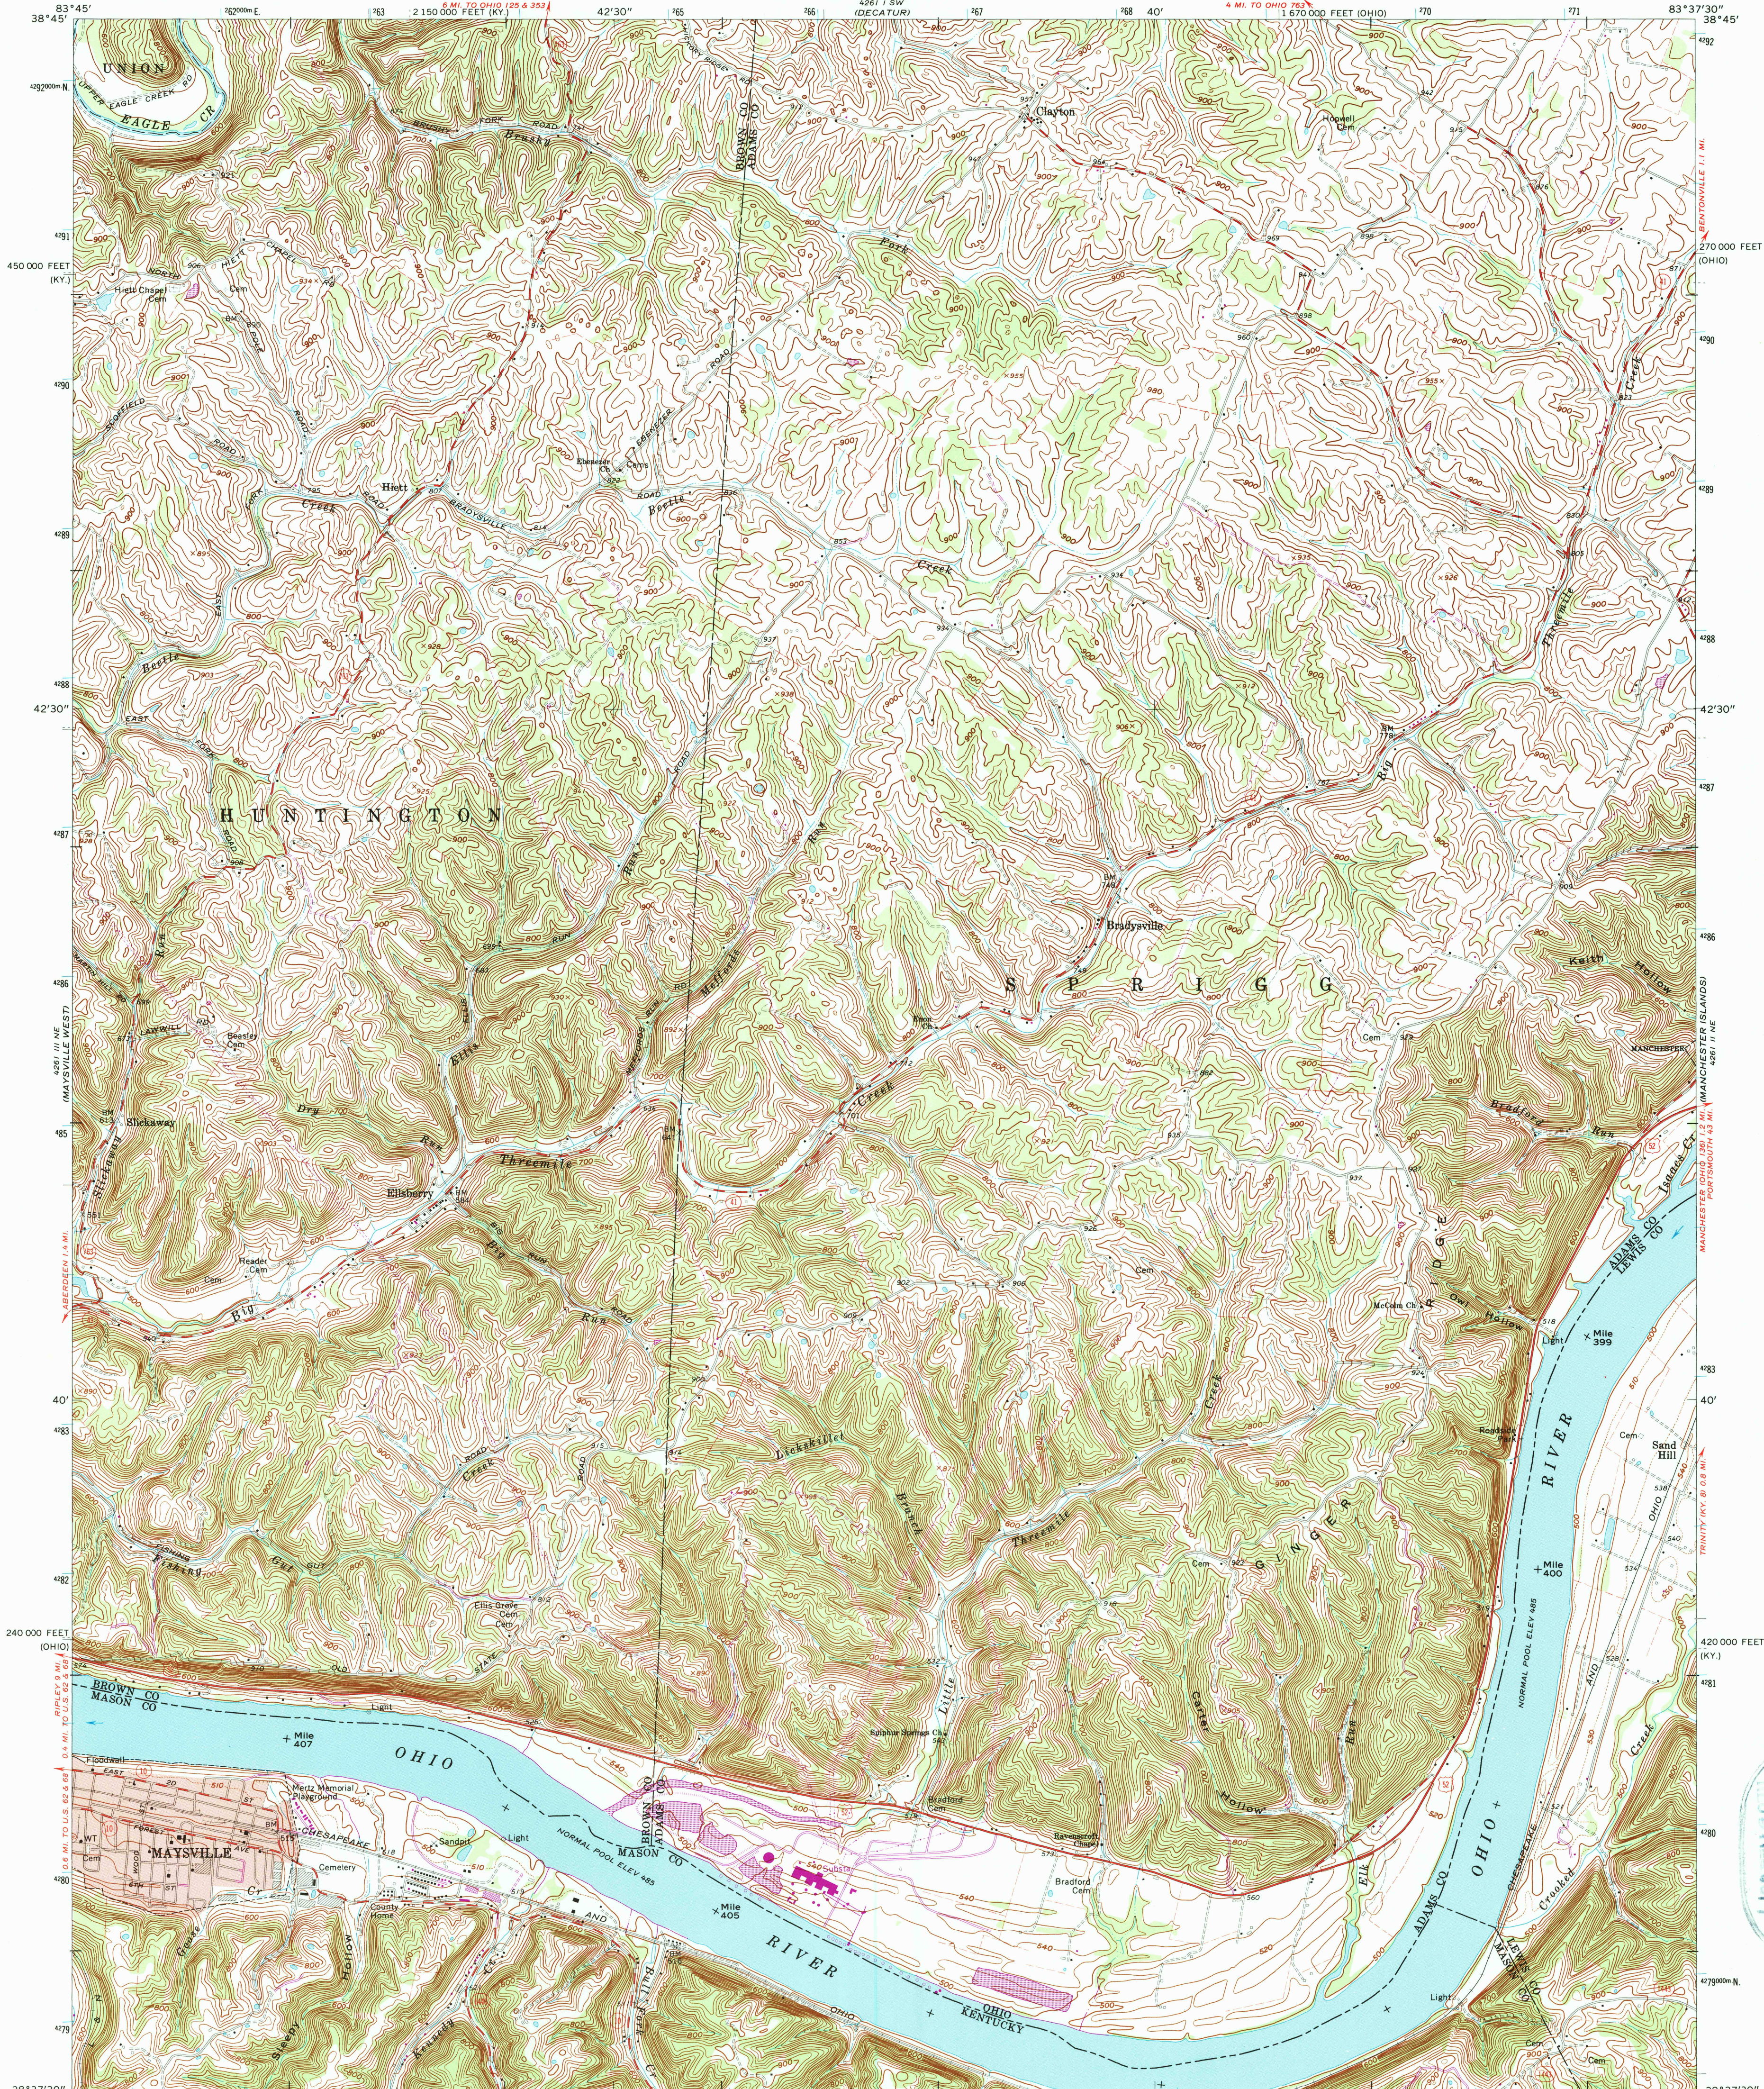
Topography in Ohio by photogrammetric methods from aerial  
photographs taken 1960. Field checked 1961

Topography in Kentucky by photogrammetric methods from aerial  
photographs taken 1950. Field checked 1952. Revised 1961

Polyconic projection. 1927 North American datum. 10,000-foot grids  
based on Ohio coordinate system, south zone, and Kentucky coordinate  
system, north zone. 1000-metre Universal Transverse Mercator grid  
ticks, zone 17, shown in blue

The state boundary as shown represents the approximate position of the  
low water line as determined from U. S. Corps of Engineers Ohio  
River charts, surveyed 1913, and supplementary information

CONTOUR INTERVAL 20 FEET  
DOTTED LINES REPRESENT 5-FOOT CONTOURS  
NATIONAL GEODETIC VERTICAL DATUM OF 1929
