UNITED STATES  
DEPARTMENT OF THE INTERIOR  
GEOLOGICAL SURVEY

CEDAR CREST QUADRANGLE  
OKLAHOMA

7.5 MINUTE SERIES (TOPOGRAPHIC)

CEDAR CREST, OKLA.  
N3600—W9507.5/7.5

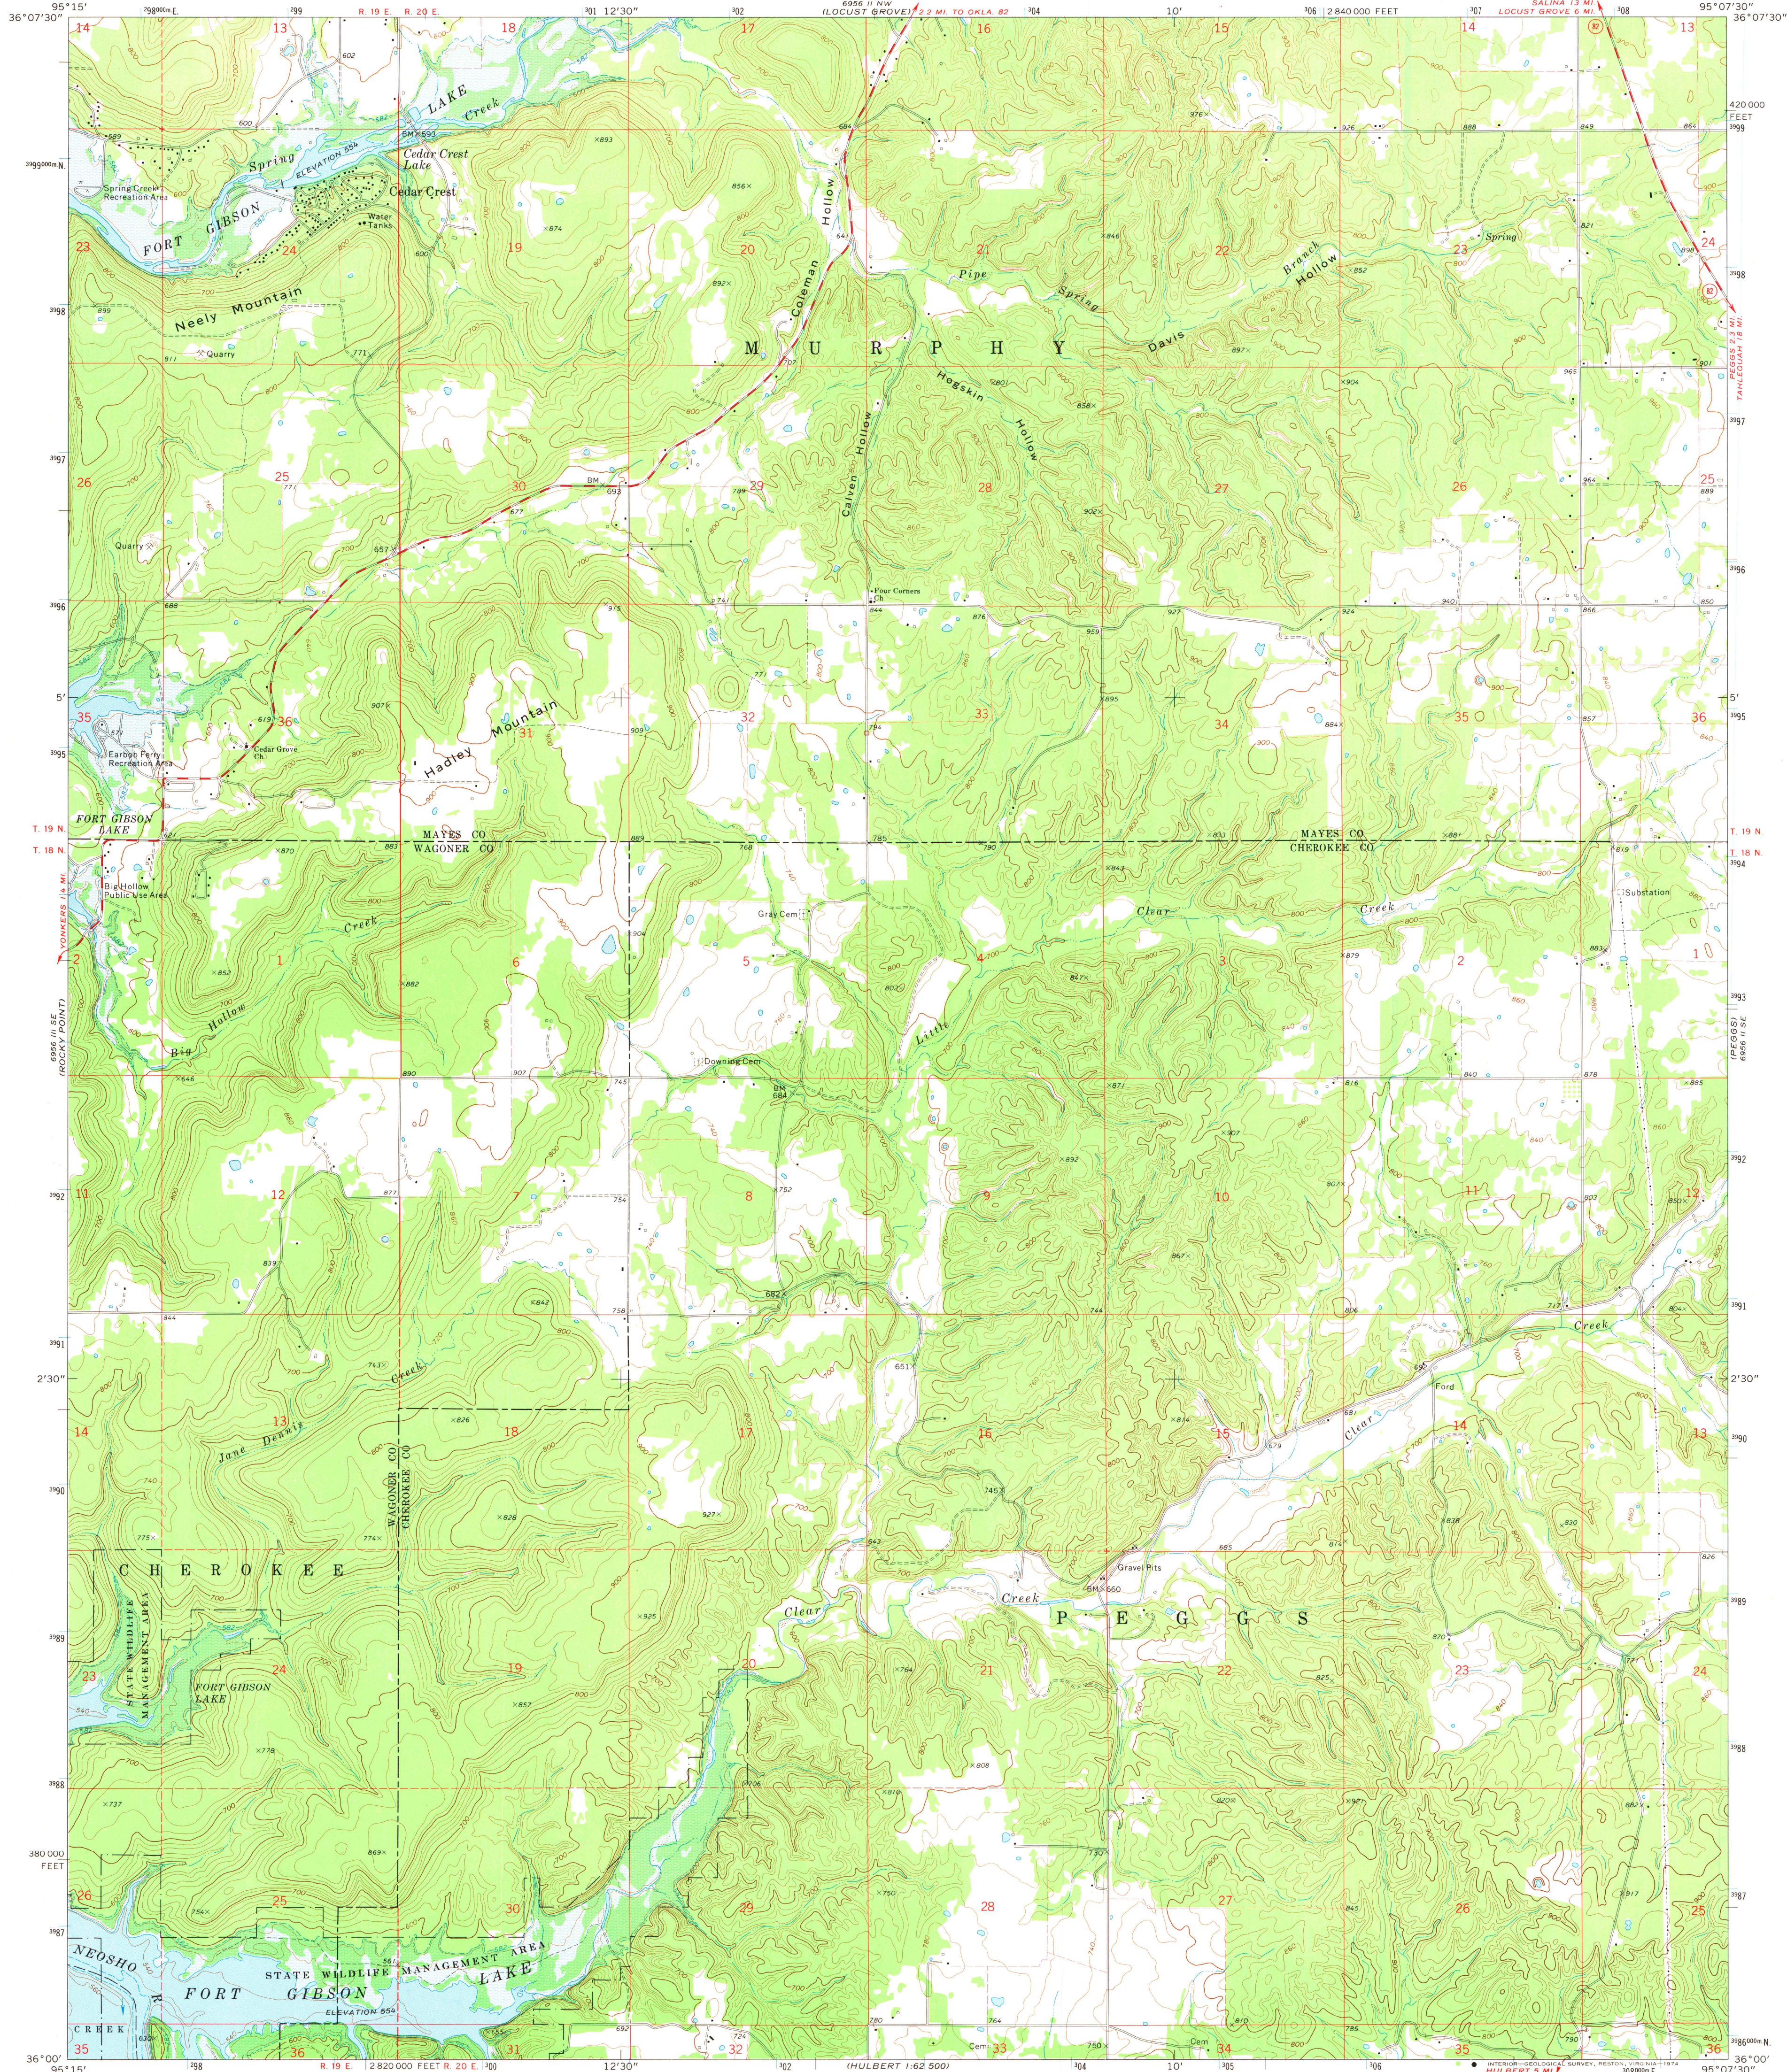
Topography by photogrammetric methods from aerial  
photographs taken 1971. Field checked 1972

Underwater contours in Fort Gibson Lake  
from USCE maps dated 1944

Areas covered by dashed light-blue pattern  
are subject to controlled inundation

Fine red dashed lines indicate selected fence and field lines where  
generally visible on aerial photographs. This information is unchecked
