UNITED STATES  
DEPARTMENT OF THE INTERIOR  
GEOLOGICAL SURVEY

COPAN QUADRANGLE  
OKLAHOMA-KANSAS  
7.5 MINUTE SERIES (TOPOGRAPHIC)

COPAN, OKLA.-KANS.  
N3652.5-W9552.5/7.5

1972  
PHOTOREVISED 1982  
DMA 6857 IV NW-SERIES V883

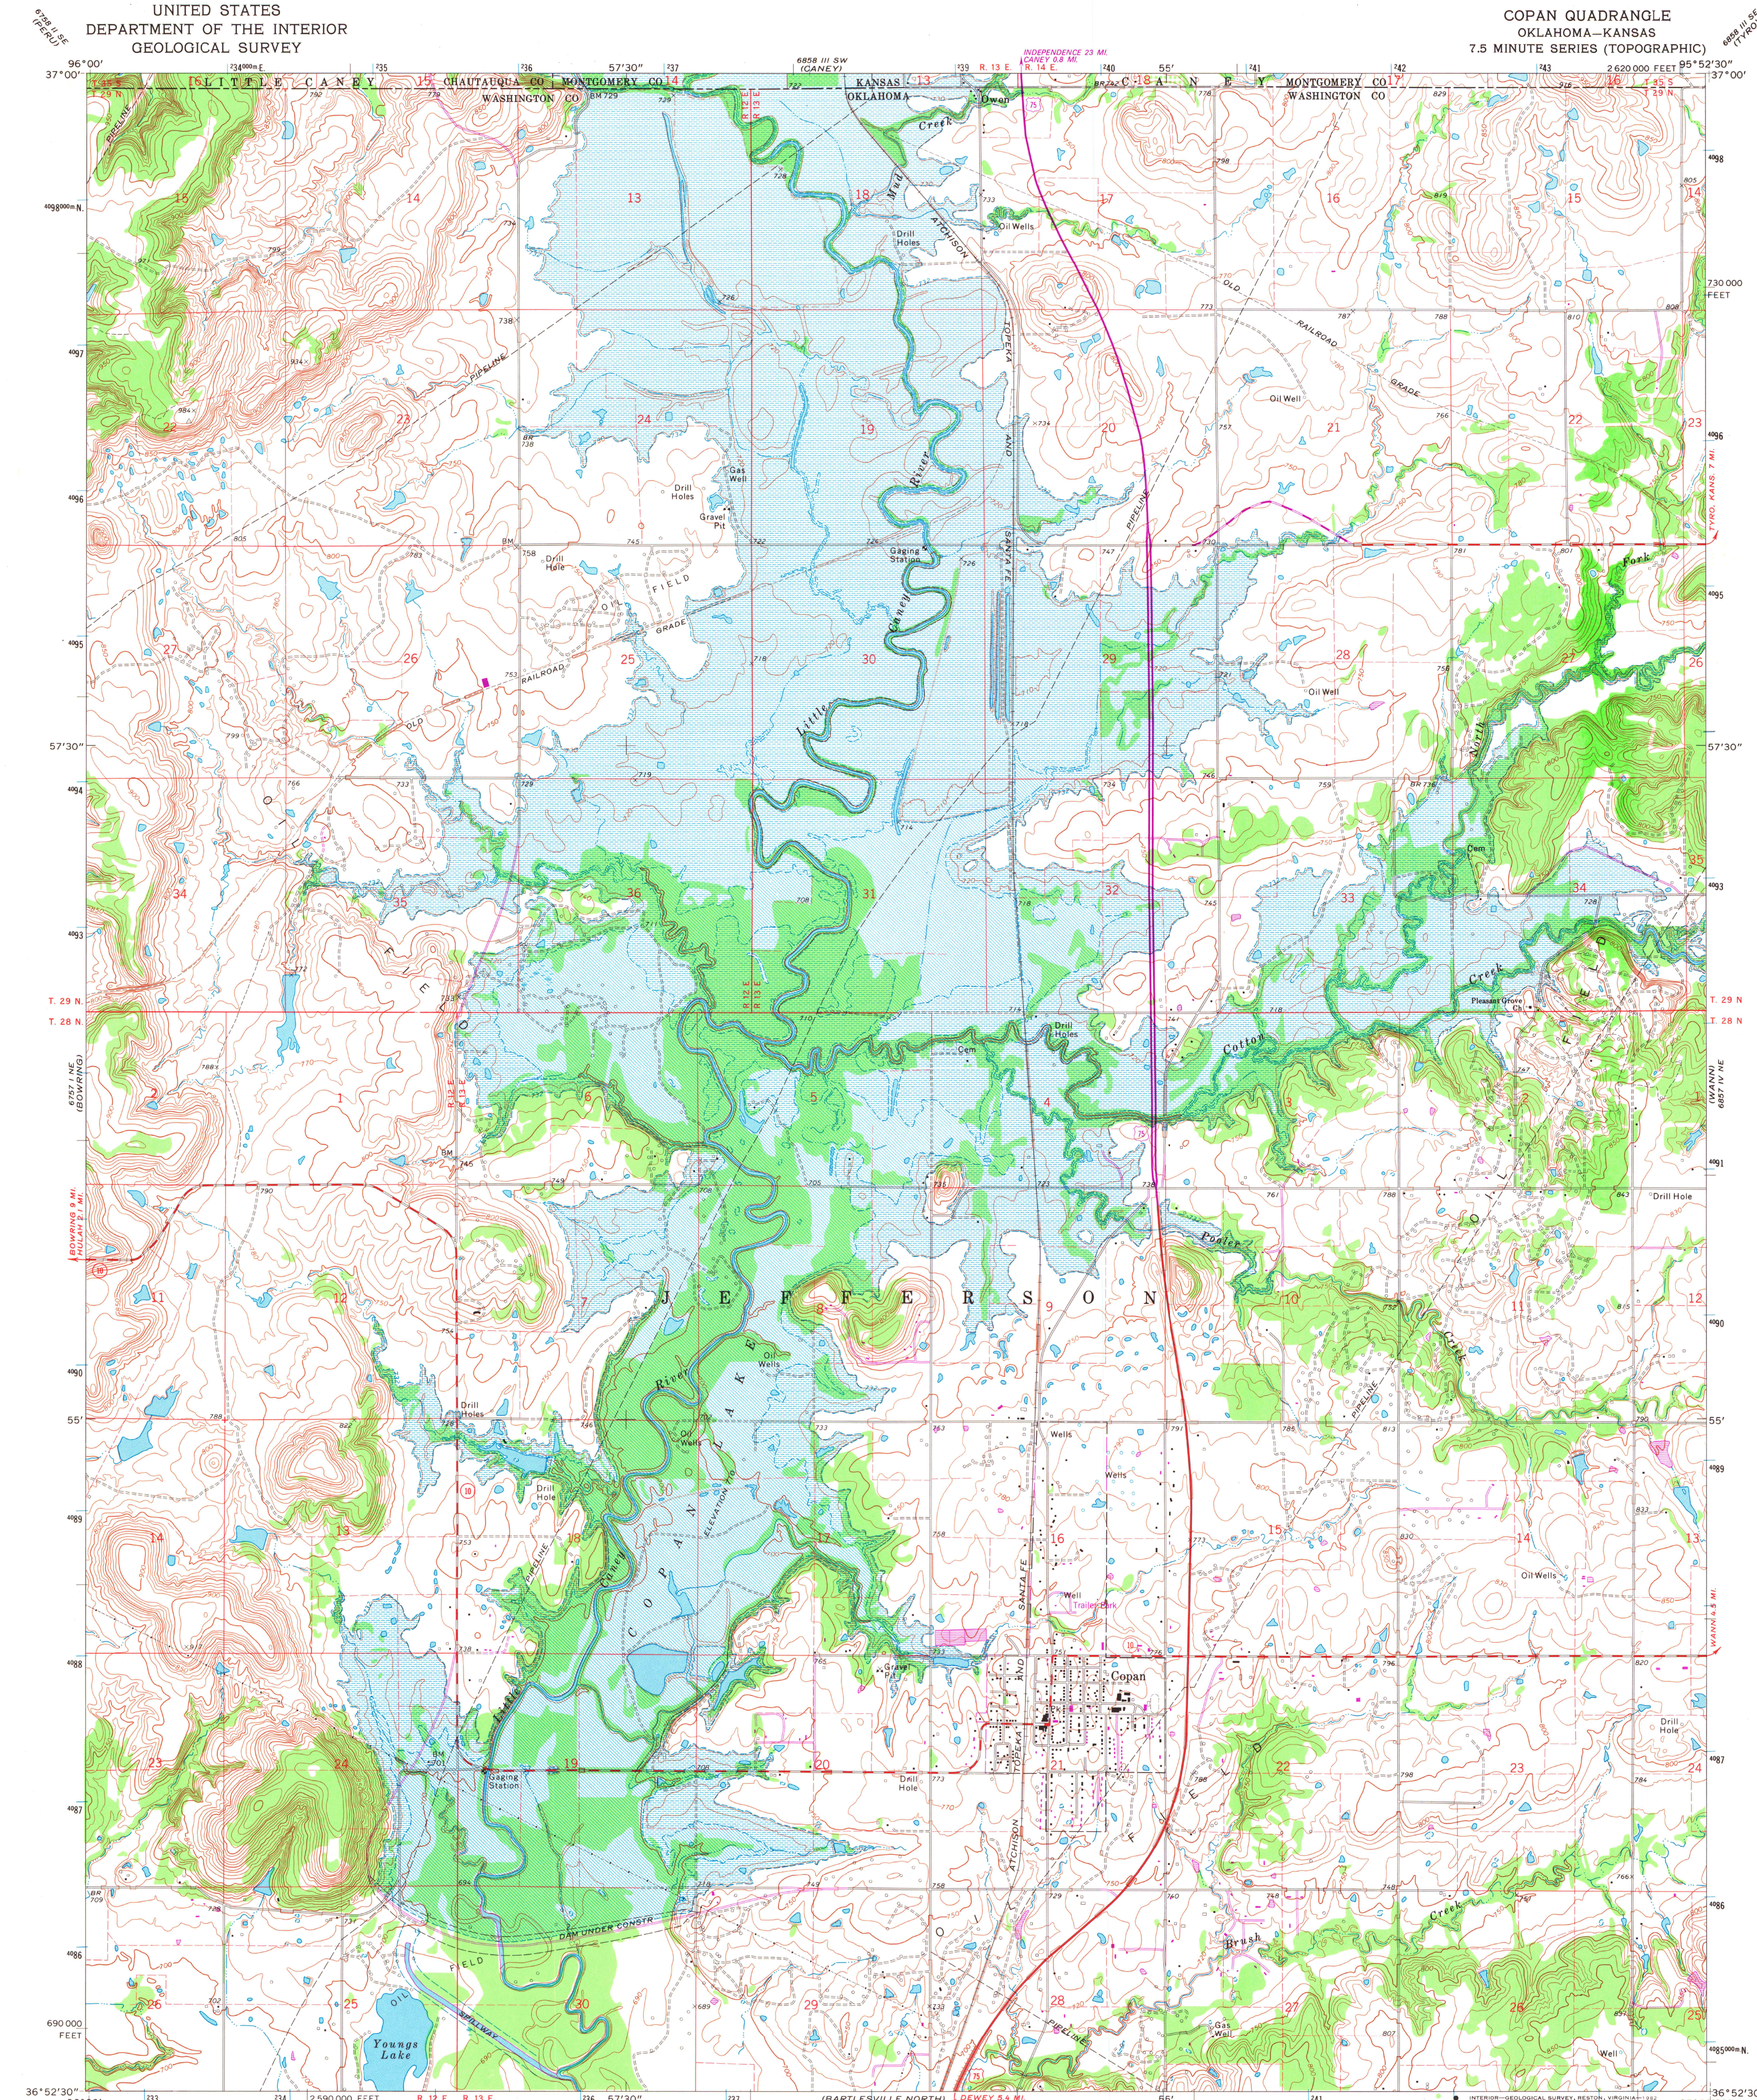
Topography by photogrammetric methods from aerial photographs taken 1971. Field checked 1972

Blue hatching indicates areas to be submerged by Copan Lake

Areas covered by dashed light-blue pattern are subject to controlled inundation

Fine red dashed lines indicate selected fence and field lines where generally visible on aerial photographs. This information is unchecked

Revisions shown in purple compiled from aerial photographs taken 1980 and other sources. Map edited 1982  
This information not field checked
